# TS440S Repair FAQ

10-29-02 by Mike Freeman KC8QNO

I recently ran into some problems with my Kenwood TS-440S. Here is a list of my problems.

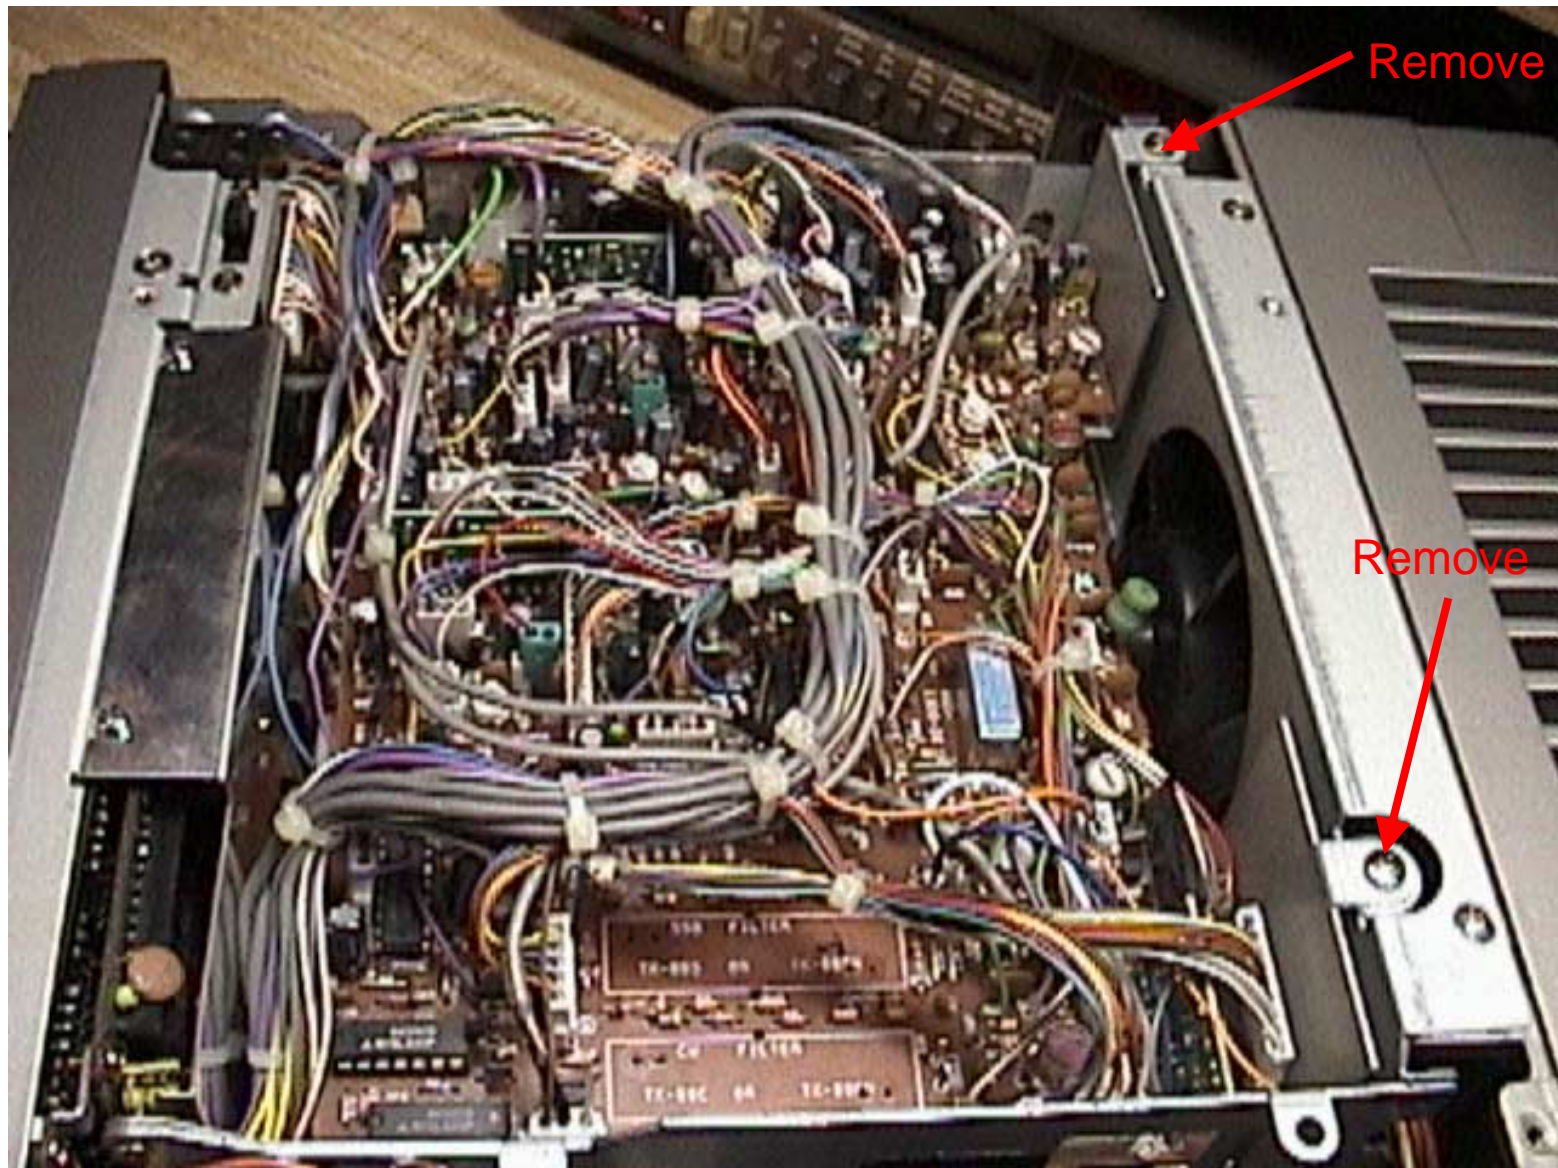
This is the TS-440S with no top cover. You can see the IF Board. Remove the two screws to expose the PLL board underneath.

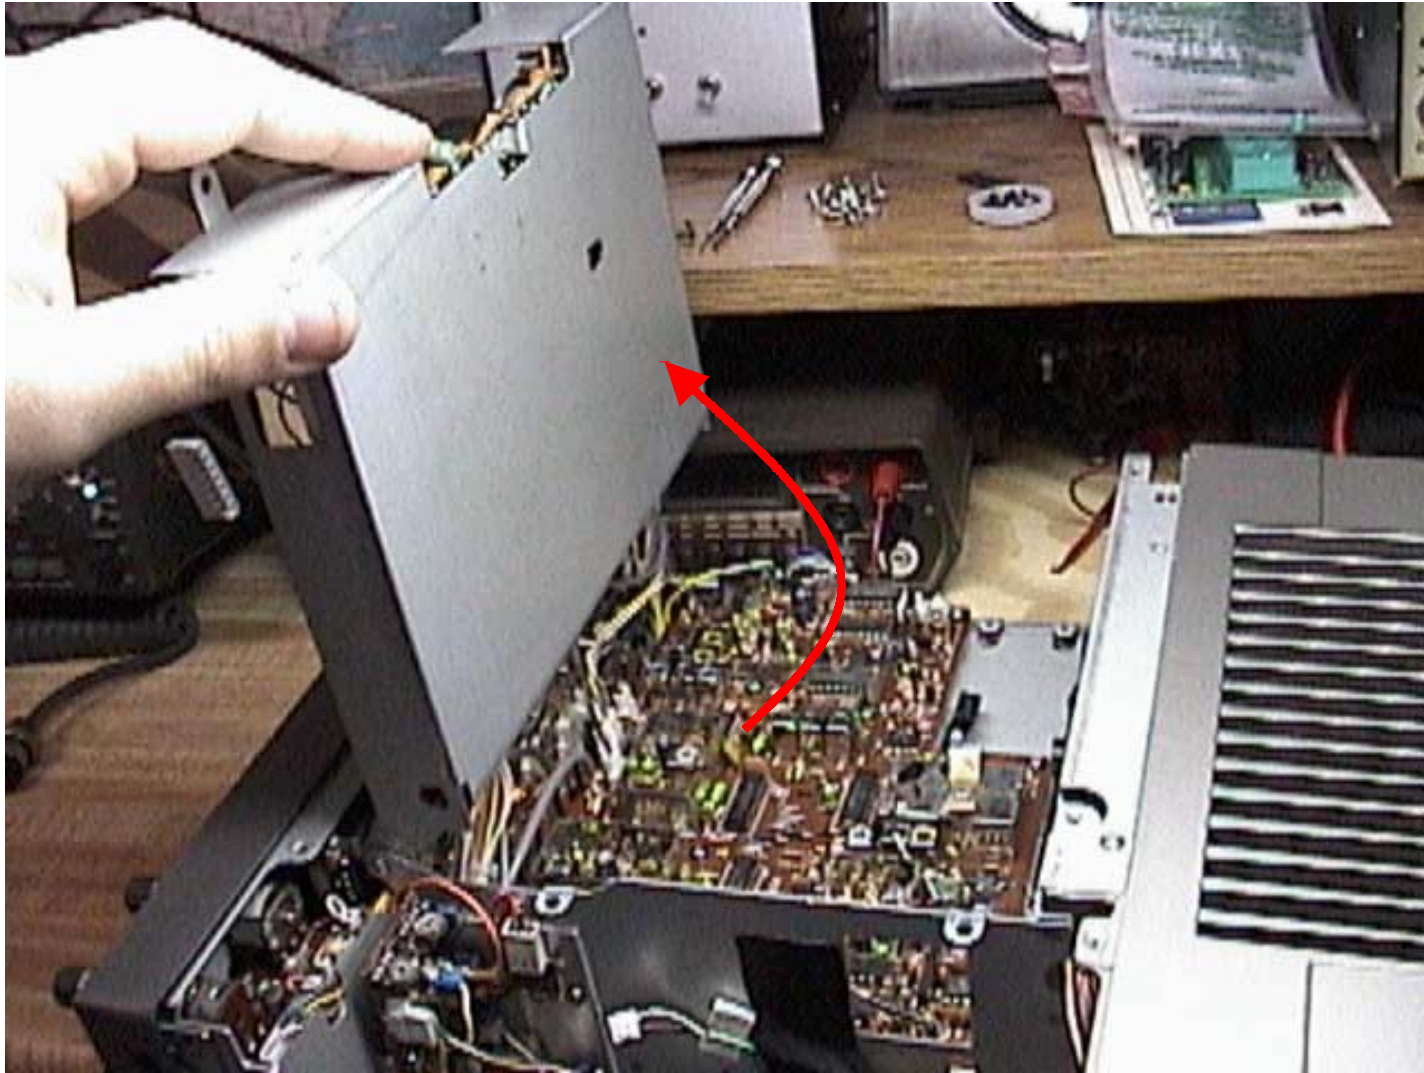
The IF board will swivel up on a hinge exposing the PLL Board. It may be necessary to unplug a few cables on the IF board to get it to lift up.

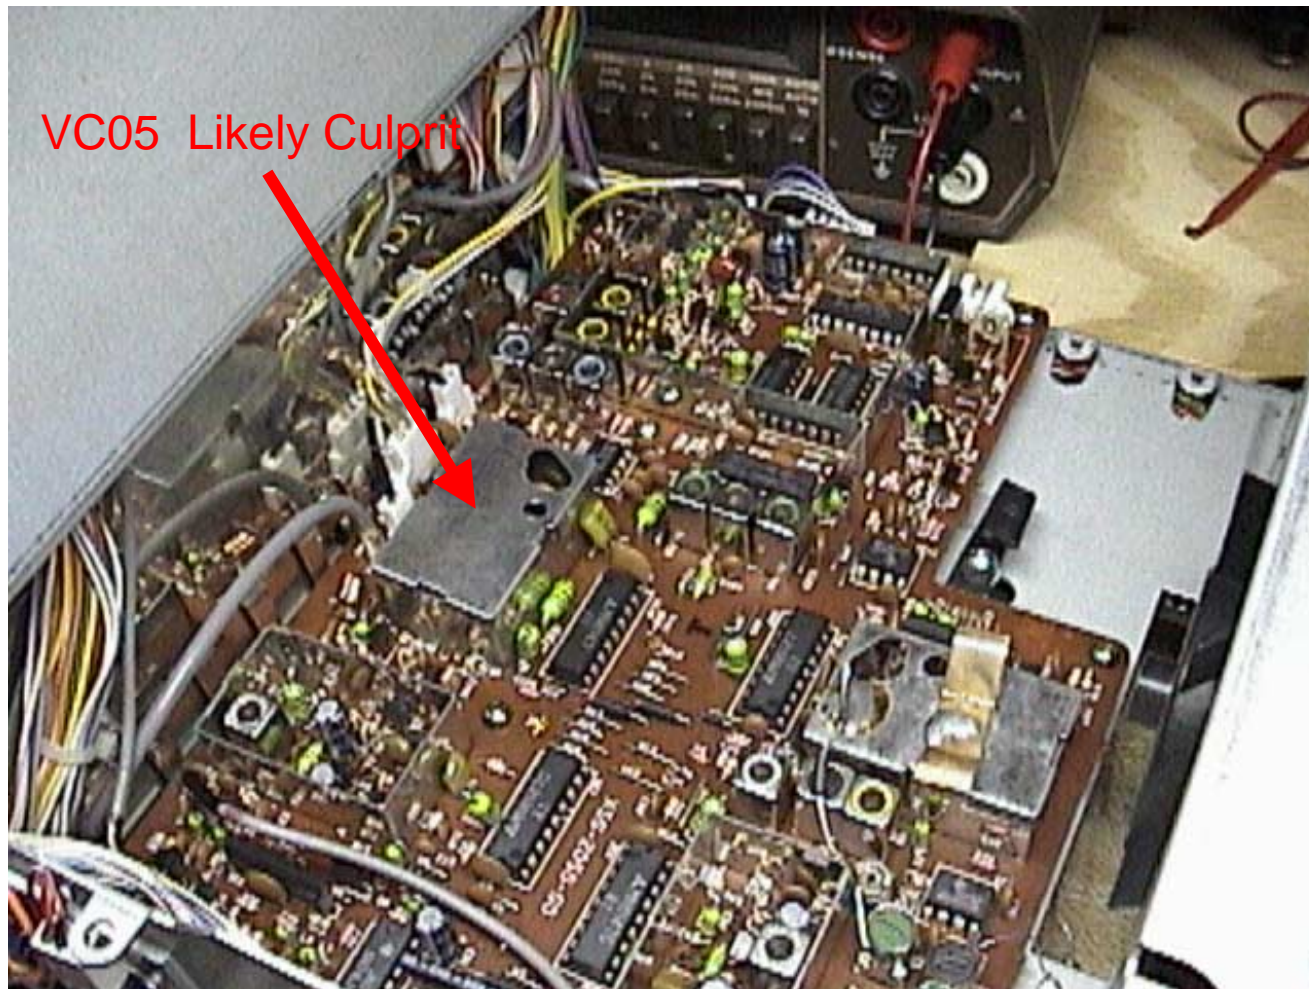
PLL board. Located under the IF board.

VCO5 has a stabilizing compound “glue” to help secure the components during mobile operation. After time this compound can get conductive and cause problems in the RF board and PLL board. If it is brown or shows a few volts when you probe it to ground then its bad.

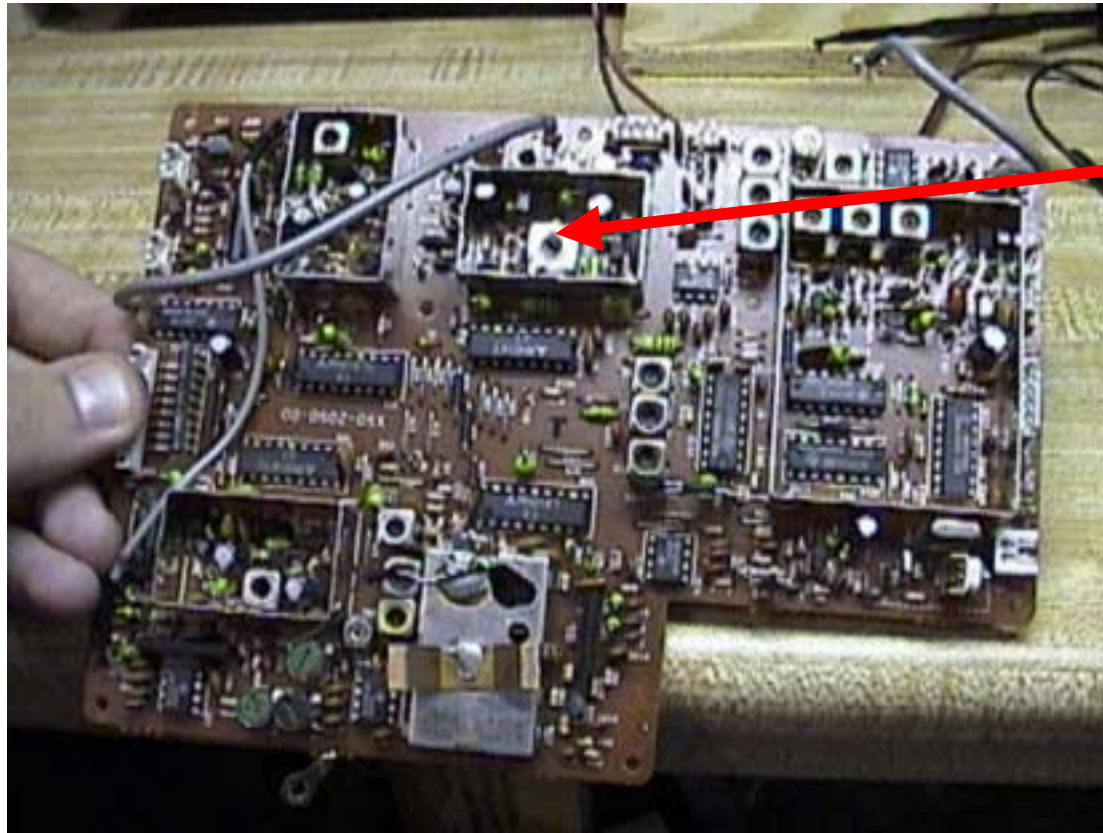
VCO5 (cover  
removed see  
next page)

Remove the PLL board from the TS440S. Remove all screws and unplug all cables. Be very careful not to break anything. Also remember where all the cables went. Draw on a piece of paper if it helps you out. I had this board out so many times I memorized everything. (hopefully you do not have to do that like I did!)

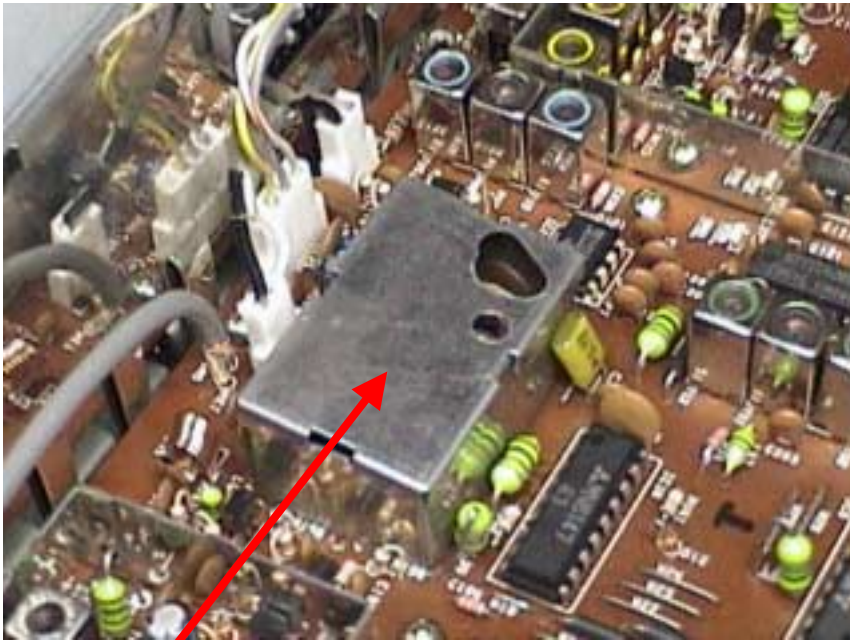
VCO5 on PLL board with top still on.

The top easily pops off with a small screwdriver.

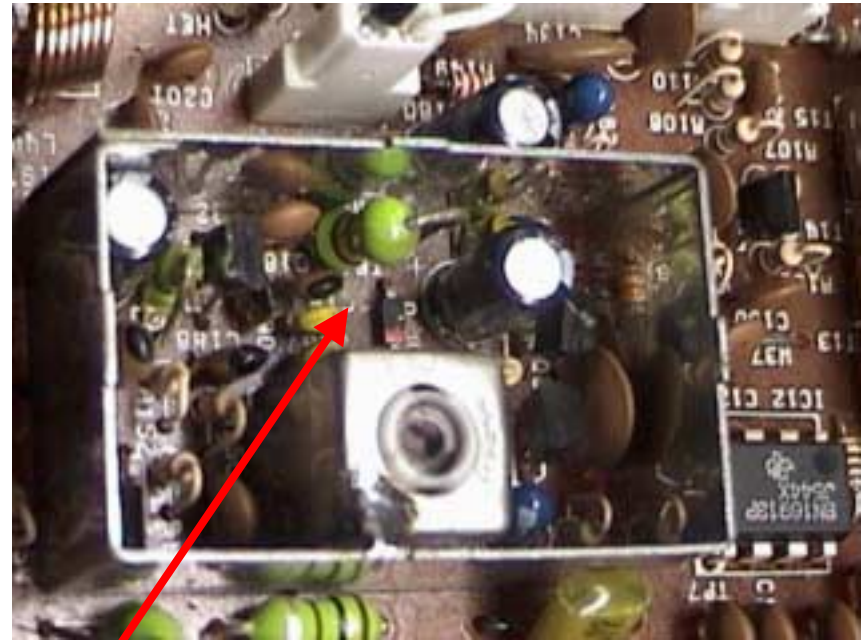
VCO5 on PLL board with top off.

The "glue" is located here. I am showing my VCO5 after I removed all the glue. (I forgot to take a pic of it before). I removed it with a pick and tweezers. I had to remove a few components to get the glue all out from the contacts. Make sure you remove it all. You may have to unsolder the metal shield around the VCO to get all the glue out.

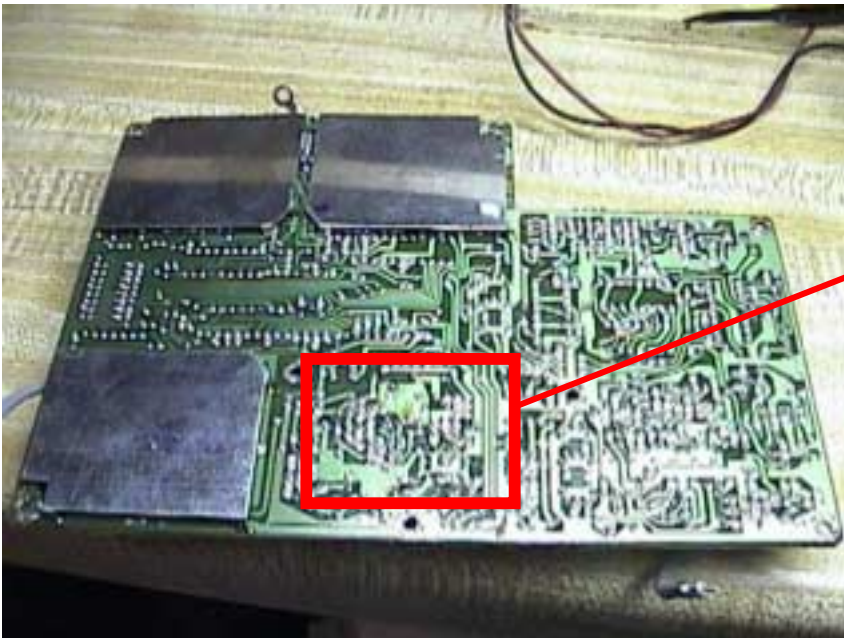
PLL board (solder side)

Now, since you got the PLL out. Flip it over and check for cold solder joints. Check the VCO5 Area (see below). Use lots of light and a magnifier of some sort. A bad solder joint will have a slight ring around it, also it may have some whitish-grey oxide on it. To be safe I re-soldered all points in this area. Make sure you do not get sloppy and solder multiple contacts together.

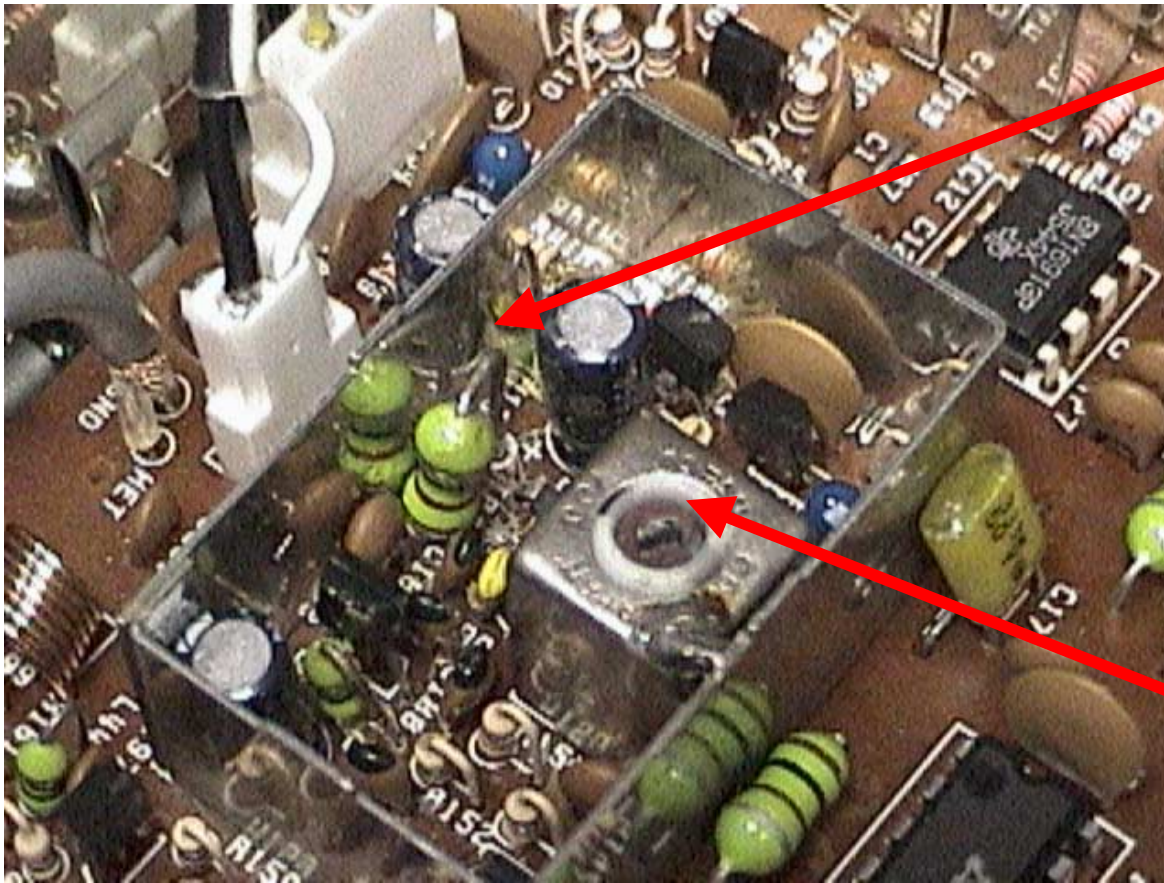
TP11. Exposed end of Inductor. This is where you want to take a voltage reading from. Connect the red lead here, and the black lead to any point on the chassis (ground).

Adjust with a small screw driver until you get a reading of 5.00 Volts from TP11.

VCO5 on PLL board with glue removed.

In order to check VCO5, you need to have all your cables plugged in and the PLL board replaced. Turn on the radio for about 30 minutes to warm up, set it for 14.200Mhz USB. You should get 5.00 Volts on a good DMM. If not, adjust (very slightly) the metal can. Replace VCO cover when done.

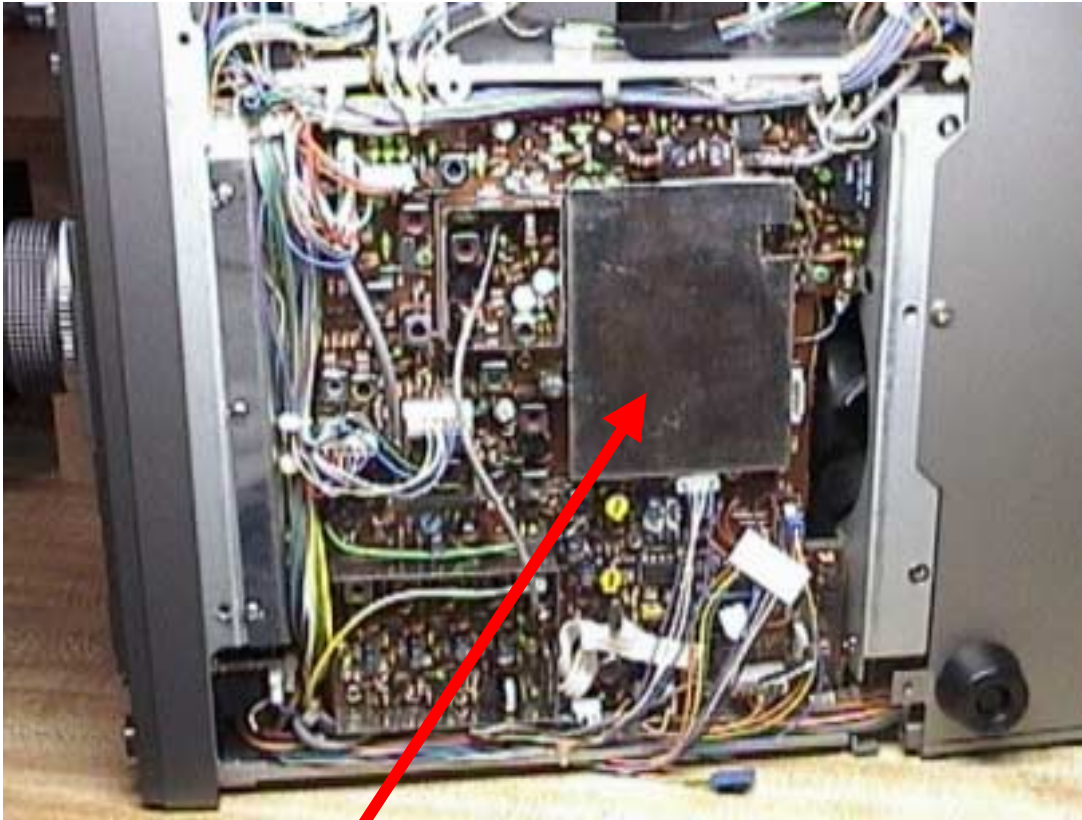
If you still are having problems, flip the rig over and take the bottom cover off. You now are looking at the RF board.

This is the area on the RF board that contains the Band select circuitry. Carefully remove this metal shield to expose the components.

If you are still getting Garbled sound or dots on your display, it may be in this area. (as it was for me). So we are going to check to see if there are any leaky diodes in here. Do not remove the RF board from the TS-440S yet. Leave it in because we are going to check for leaky diodes first. I removed it for reasons explained later on.

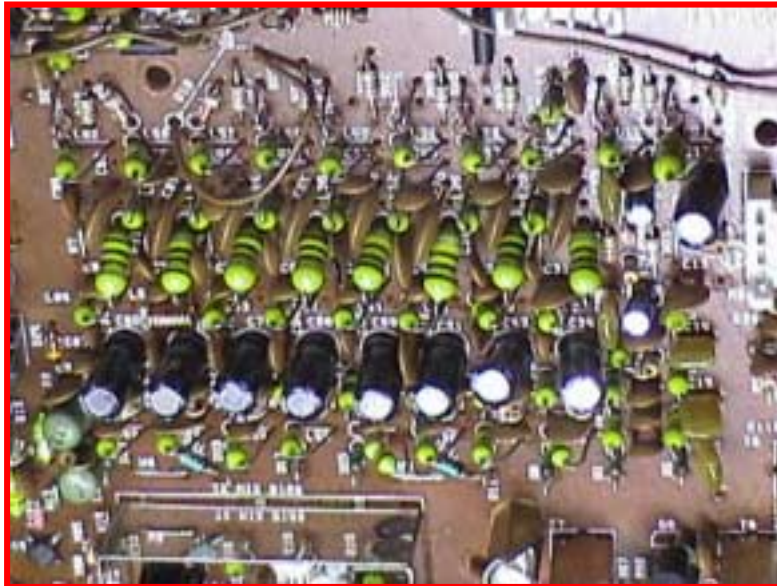
RF Board - Close up of band select filters (metal shield removed).

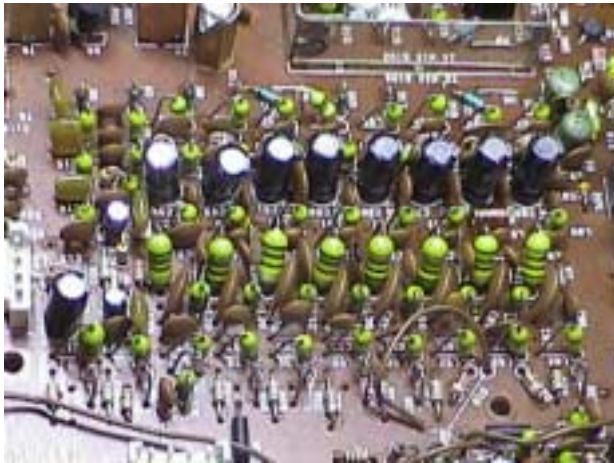
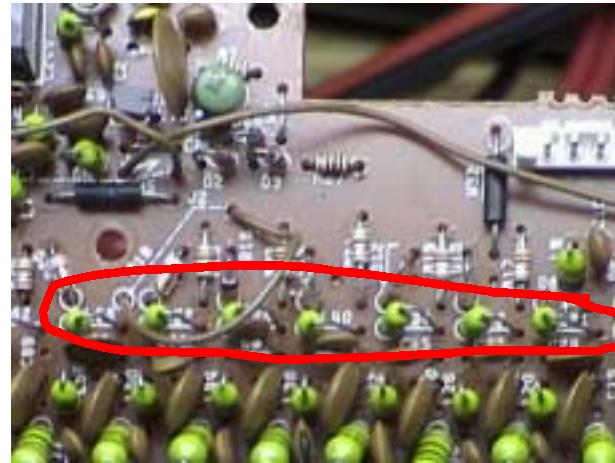
These yellow  
inductors are  
your test points.  
Follow directions  
below.

The most common symptom is the PLL unlock. Reset the transceiver by holding in the A=B button as power is turned on. Even if the display only shows decimals, only the (band pass filter) BPF for 14 MHz should be turned on. Using a DC voltmeter, measure the voltage at coils L11, L15, L21, L28, L34, L40, L46, L52, L58, and L62. Only coil L52 should measure 8 Vdc. The other coils should read 0 Vdc. If one reads 0.5 - 8 Vdc, replace the two diodes in that BPF circuit.

Replace diodes with 1S2588 ,1SS91S or 1S1587 (I used these)

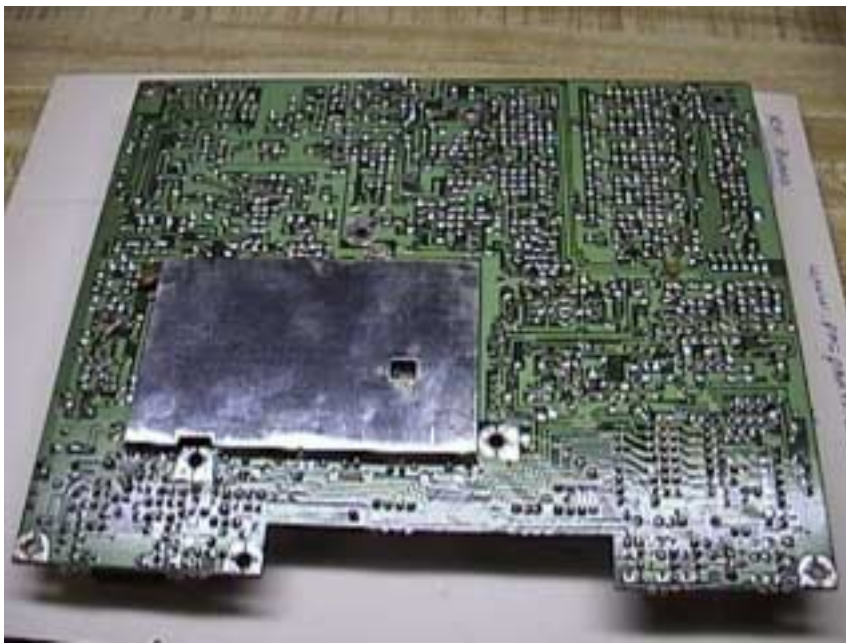
RF board removed (solder side) with shield.

If you find a bad diode remove the RF board carefully (like you did with the PLL board). Notice the metal shield? Well you guessed it, you must carefully remove it by unsoldering it from the RF board.

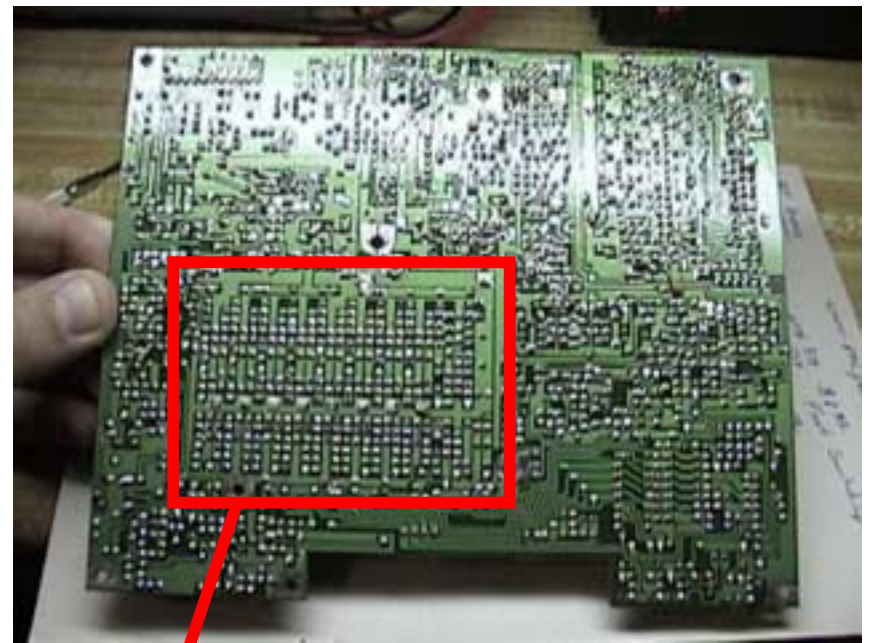
RF board removed (solder side) no shield.

After the shield is removed, replace your diodes. Also, very important. Check for bad solder joints here. I found several and repair as necessary in the entire area. This is a very likely area if you have dots on your display only on one frequency. Its because of broken solder joints.

Again, do not get sloppy with the solder in here! Very Bad!

Once you are done, put the RF board back into the TS-440. Make sure you check all cables. Plug everything in, leave the top and bottom covers off for now. Turn the rig on. Does it work? Is it fixed? Hopefully so, but if not, go back and check for more broken solder joints. Particularly in the VCO5 area and the BPF area on the RF board. Go back and make sure you removed all the “glue” from VCO5. I had to completely re-solder both the RF boards and the PLL boards to make mine work. This was an extreme case and I had lots of time today. Do not continue on until you get the display working.

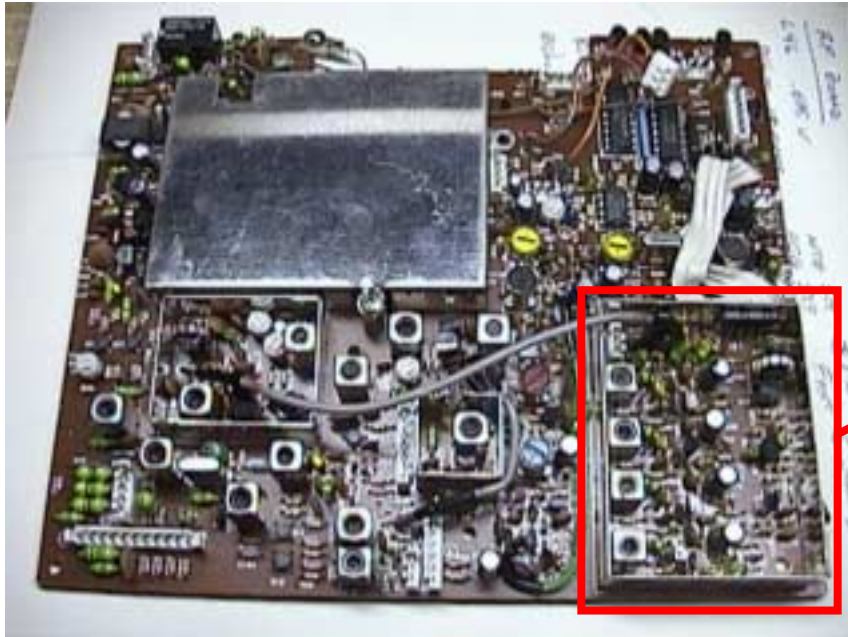
RF board.

Remember the RF board (bottom of the Rig? Don't remove yours, leave it in. But look at it. See the 4 cans to the right?

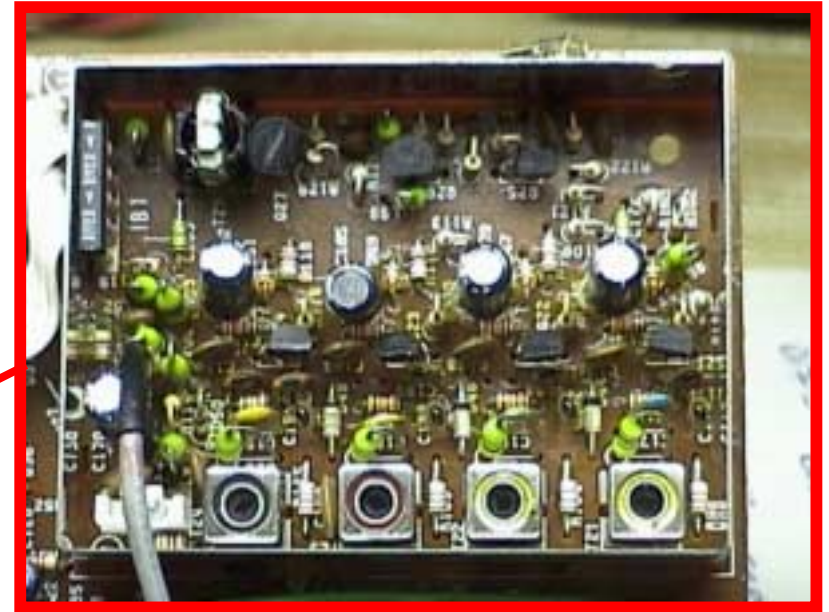
VCO cans.

We are now interested in this area. These are the cans that adjust your VCO1's (I believe the adjust the PLL locking for VCO1). From left to right they are:

T24,T23,T22,T21

**29.9999 Mhz, adj T21 for 2.5 volts on TP10**

**21.9999 Mhz, adj T22 for 2.5 volts on TP10**

**14.4999 Mhz (this is where the svc manual was in error, it says 14.9999), adj T23 for 2.5 volts**

**7.4999 Mhz, adj T24 for 2.5v**

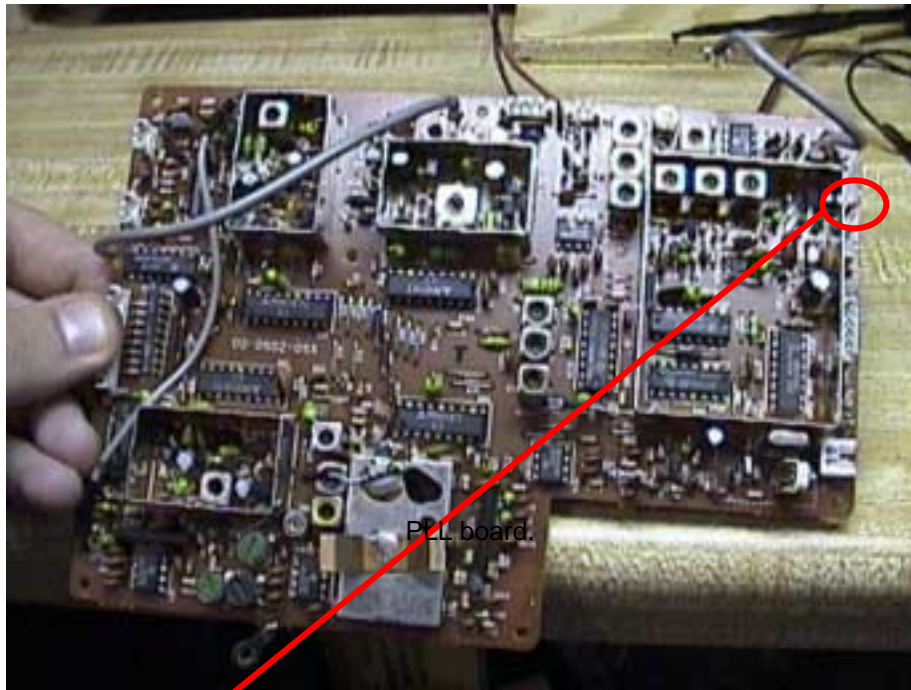
**R138**

Also, remember the PLL board? Again, leave yours in. Do not remove it. You want to find R138. Your voltage test point is the exposed lead of this resistor. You should be able to see it with the IF board secured down. Just place your rig on its side and look for this resistor on the edge.

**Measure at R138, TP10 on the PLL unit, with DC VOM**

**Check at 22.0000, 14.5000, 7.5000 and 30.0 kHz, for TP10 to read around 5.3-5.5 volts, not critical as long as it isn't above 6.2 volts.**
